## Case study

## Analysis of internal corrosion in subsea oil pipeline

M.N. Ilman\*, Kusmono

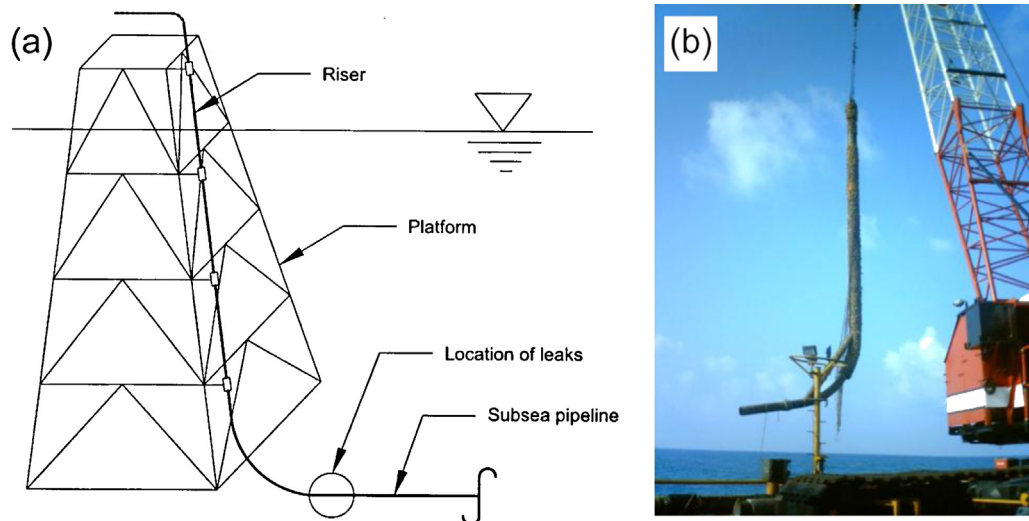
Recently, oil leaks have been reported to occur at a horizontal crude oil subsea pipeline after 27 years in service. A schematic diagram of the crude oil flow and the actual picture of the failed crude oil pipeline under investigation are shown in Fig. 1. During operation, crude oil was pumped from subsea wells into the horizontal pipeline. The crude oil then flowed out the pipeline directly into a long radius elbow section which turned the crude oil flow vertically allowing the flow to pass through a riser for further processing in platform.

Some oil leaks were observed at the bottom of the horizontal pipeline just before the flow entered the elbow section. No other areas of damage were identified during inspection. Details of the failed pipeline and its operating data are as follows.

Fig. 1. (a) A schematic diagram of subsea pipeline-riser configuration, (b) a view of the failed subsea pipeline.

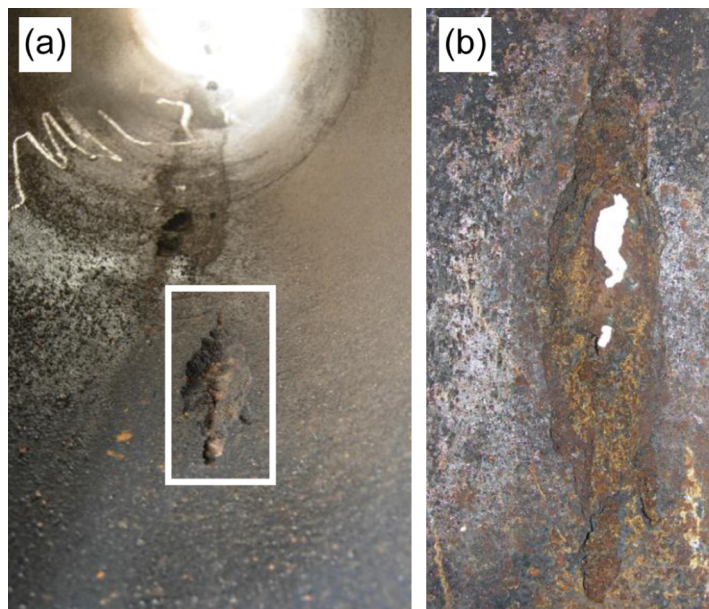
Fig. 2 shows visual examination results of leaks found in the pipeline. As is seen, the leaks were mainly observed at the inner surface of the pipeline. These leaks were nucleated locally at the bottom of pipeline (6 o'clock position) in the form of teardrop-shaped pits or grooves which elongated parallel to the fluid flow direction. This type of failure leads to hypothesis that the leaks are resulted from combined effect of electrochemical corrosion and fluid flow. However, this preliminary analysis needs to be verified by more detailed characterizations as shown later.

Fig. 2. (a) Leaks found at the inner surface of pipeline at 6 o'clock position, (b) magnified area outlined by square in (a).

Based on visual analysis, it can be seen that the leaks are in the form of teardrop shaped pits or grooves at the bottom of the pipeline (6 o'clock position) where water layers preferentially form. The absence of scales or deposits around the grooves suggest that the pipeline is locally attacked by flow-induced corrosion. Such corrosion initially produces brittle scales or rusts on the pipe surface exposed to the fluid. These scales act as barrier between the metal surface and the fluid so that further corrosion penetration is inhibited. Subsequently, the fluid flow causes the erosion process and the scales or corrosion products are periodically scoured from the exposed surface hence increasing corrosion rate along the flow direction.

Ferric hydroxide [ $\text{Fe}(\text{OH})_3$ ] appears to be reddish-brown in color as shown in Fig. 2b. It seems that the  $\text{Fe}(\text{OH})_2$  or  $\text{Fe}(\text{OH})_3$  deposits resulted from corrosion reaction are then scoured from the exposed surface by the fluid flow hence increasing corrosion rate along the flow direction. As a result, the corrosion rate at the spread of corrosion downstream is higher than that of penetration and sideways. Such corrosion attack changes from pinhole shape, typical of purely corrosive attack to become teardrop-shaped pits or grooves.

1. Flow induced corrosion seems to be the main cause of leakages that occur locally at the horizontal subsea pipeline near an elbow section.
2. Combined effect of pitting corrosion and erosive flow increases corrosion rate along the flow direction resulting in teardrop-shaped pits.
3. The damage prevention options are suggested: first, prevent water separation by increasing oil flow sufficiently so that the pipeline surfaces are maintained oil wetted and secondly, give inhibitor injection into an oil pipeline fluid stream.

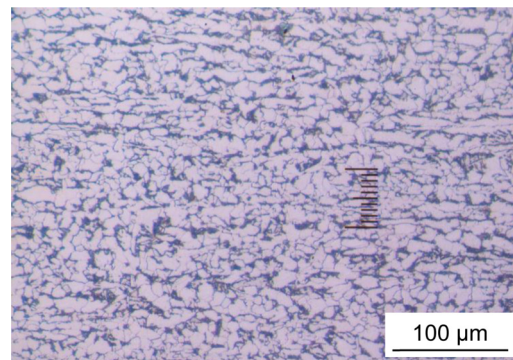
Fig. 3 shows an optical photomicrograph of the pipeline under study. It can be seen that microstructure of the pipeline is composed of ferrite and pearlite as commonly seen in low carbon steels. These fine grained ferrite and pearlite are elongated along rolling direction known as texture. Such microstructure can give high strength in steels via grain refinement according to Hall–Petch relationship and good impact toughness to meet stringent requirements of pipeline material.

Fig. 3. Microstructure of the pipeline under investigation.

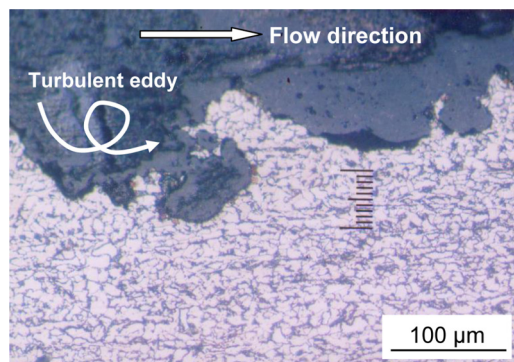
Fig. 4 shows a surface profile taken from longitudinal section of the teardrop-shaped pits. Based on the surface profile, it seemed that the crude oil flow produced undercutting in the downstream direction probably due to the presence of turbulence. The interpreted turbulent eddy is indicated by an arrow in Fig. 4.

Fig. 4. Surface profile of the pipeline along the flow direction.

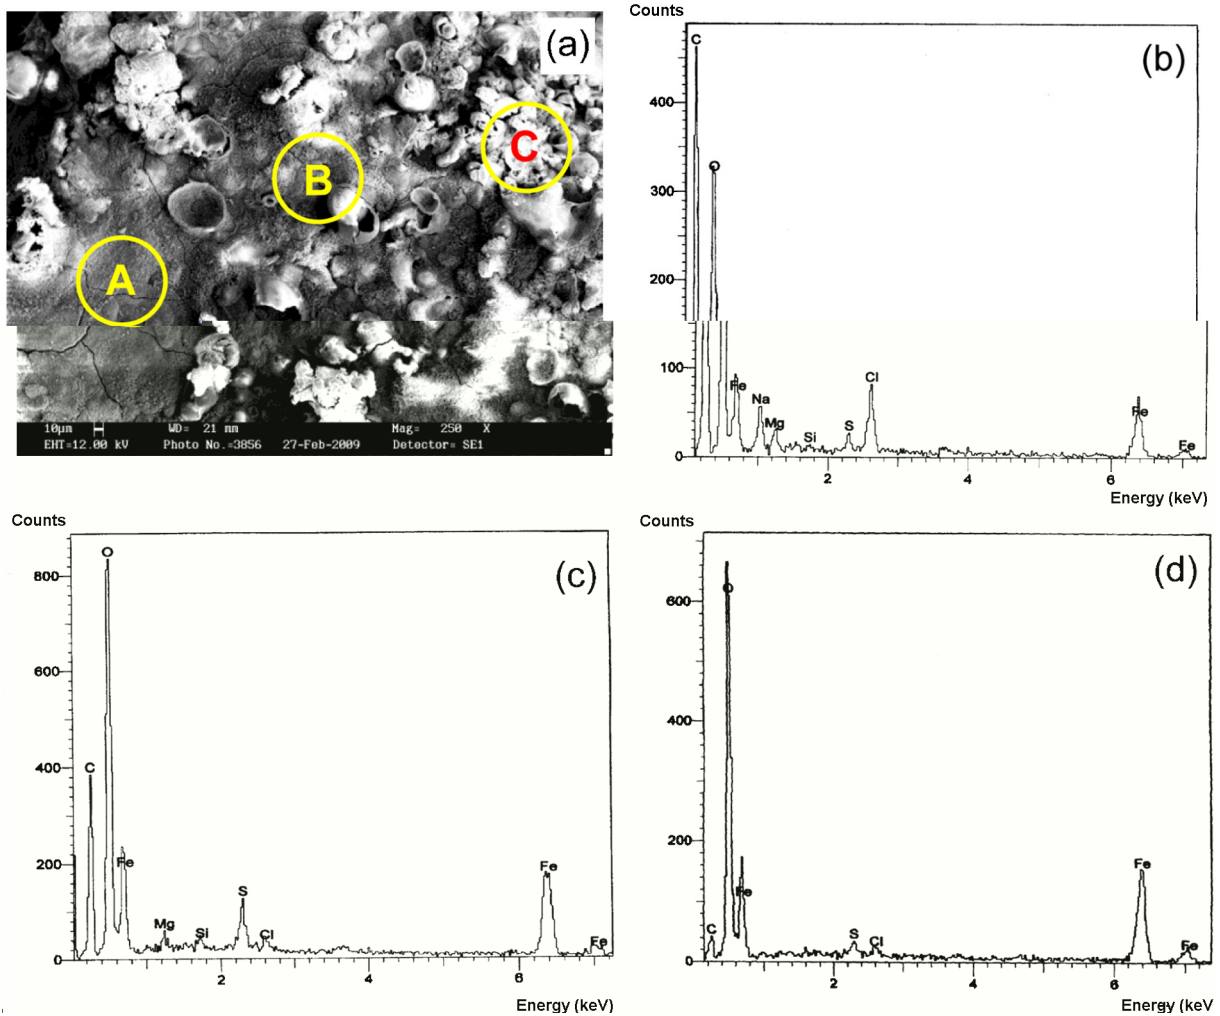
Results of SEM microanalysis on the corroded surface near corrosion pits are shown in Fig. 5a with the EDX-spectra are shown in Fig. 5b–d. It can be seen that the region marked A in Fig. 5a is the inner layer of corrosion product where this layer is directly in contact with the steel pipeline surface. EDX-microanalysis taken from this region reveals elements such as Fe, O, C, Cl with low levels of Na, Mg, Si and S (Fig. 5b) suggesting that this inner layer is in the form of  $\text{FeOCl}$  as a result of chloride attack on hydrated passive film ( $\text{FeOOH}$ ). Region marked B in Fig. 5a seems to be intermediate layer and it is composed of mainly Fe and O with a considerable amount of S as shown in Fig. 5c. At outer deposit, i.e. the region marked C in Fig. 5a, oxygen easily comes into contact with the deposit and as expected, this deposit consists of mainly Fe and O (Fig. 5d), probably in the form of hydrous ferrous oxide  $\text{Fe}_2\text{O}_3 \cdot n\text{H}_2\text{O}$  or ferrous hydroxide  $\text{FeO}(\text{OH})_2$ .

It seems that the chemistry of oxides change from metal-rich to oxygen-rich as the distance moves from metal-oxide interface (Fig. 5b) to outer deposits (Fig. 5c and d). These various corrosion products are consistent with the works reported by some researchers [4,5]. Of note is that C present in corrosion products probably comes from hydrocarbon and/or bicarbonate ( $\text{HCO}_3^-$ ) whereas Cl is resulted from chloride ions ( $\text{Cl}^-$ ) dissolved in water. The presence of S in corrosion deposits is likely associated with  $\text{SO}_4^{2-}$  in the water. Sulfate,  $\text{SO}_4^{2-}$  is anionic sulfur species in which S is fully oxidized state with the oxidation number of +6 and it is relatively unreactive.

Fig. 5. (a) Corrosion products at the region near leaks. (b–d) EDX-spectra taken from regions marked A–C, respectively, in (a).

The presence of Cl in corrosion product as shown in EDX-spectra in Fig. 5b suggests that the mechanism in which chloride ions destroy passive film is operative.

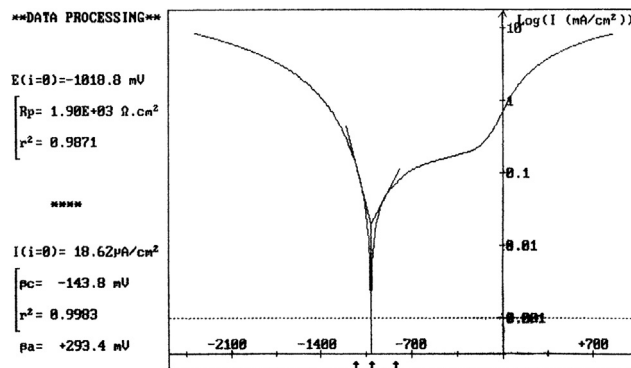
Fig. 6 shows polarization diagram (Tafel plot) for the pipeline from which the corrosion rate, given in steady state current density  $i_{\text{corr}}$  ( $\mu\text{A}/\text{cm}^2$ ), can be determined. In engineering practice, corrosion rate ( $r$ ) expressed in the form of penetration per

Fig. 6. Tafel plot for the pipeline in the water phase extracted from the crude oil.

where  $f$  is mass fraction of element in alloys. Results of corrosion rate calculation are given in Table 4. As it is demonstrated, the corrosion rate of the steel pipeline is  $18.62 \mu\text{A/cm}^2$  or equivalent to  $8.616 \text{ mpy}$  ( $0.2184 \text{ mm/year}$ ) suggesting that the pipeline material has a good corrosion resistance. Of note is that the corrosion rate measured in the laboratory test would not be the same as that obtained from on-site observation due to the facts that in the laboratory test, the surface of corrosion specimen was polished with no fluid flow during the test and test temperature was lower than the actual operating temperature. However, from the view point of passivity behavior, the polarization test may give useful information on active-passive behavior of steel pipeline in aqueous environment.

Referring to Fig. 6, it can be seen that at the potential range of  $-700$  to  $-175 \text{ mV SCE}$ , the pipeline exhibits passivity presumably due to the formation of passive film [6,7].

Breakdown of passivity starts to occur at the potential of  $-175 \text{ mV SCE}$  or higher suggesting that the steel pipeline has susceptibility to pitting corrosion. This type of corrosion could be linked to aggressive agents such as chloride which destroy the passive film locally and catalyze the liberation of  $\text{Fe}^{3+}$  according to [8]:

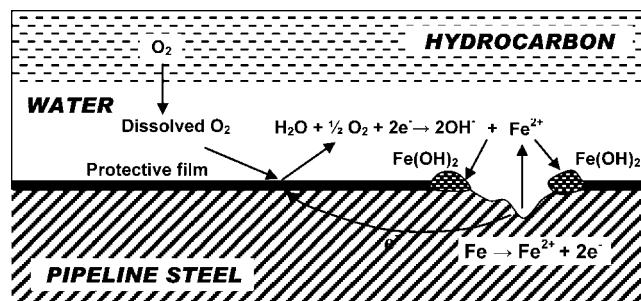
Failure mechanism of the horizontal subsea pipeline due to flow-induced corrosion is described in Fig. 8. According to the flow analysis as previously discussed, the flow pattern is expected to take place in the form of stratified flow where the gas and liquid completely segregate from each other and the water layer is present at the bottom of the oil pipeline. As the crude oil flows through the elbow section, the flow must turn resulting in impacts on the regions near the bend pipeline wall. This impact combined with chloride in the crude oil, the eddy current and possibly entrainment of sand in the pipeline have a potency to destroy the protective film. Once the protective film is destroyed, the pipeline surface is exposed to water and oxidation-reduction reactions are expected to occur.

**Fig. 8.** Proposed mechanism of flow induced corrosion in oil pipelines.
