# Defect Pattern Analysis of the Alloy Steel Ingot through Scanning Electron Microscopy, Energy Dispersive Spectroscopy and Ultrasonic Test after Forging

**ABSTRACT :** In this study, the types and causes of defects found after forging and machining were analyzed for four alloy steel ingots. Forged carbon steel, silico-manganese steel, hardenability chromium molybdenum steel, nickel chromium molybdenum steel, which have undergone casting and heat treatment processes, were used as specimen materials. Ingots were produced through EAF, LF, VD, casting and slow cooling processes. The chemical composition of the alloy steel was analyzed by XRF instrument. The defects of machined ingot specimens were analyzed using ultrasonic test, scanning electron microscopy, energy dispersive spectroscopy, and optical microscopy. The most frequent ingot defect patterns in the four specimens in this study were non-metallic inclusions. As a result of SEM analysis, it seems that the cause of defects in the ingot defect part is a mixed component of the exothermic material and the de-oxidation product inclusions. It seems possible to predict cracks by simultaneously considering the internal crack temperat

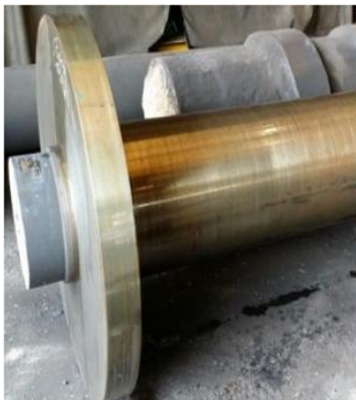
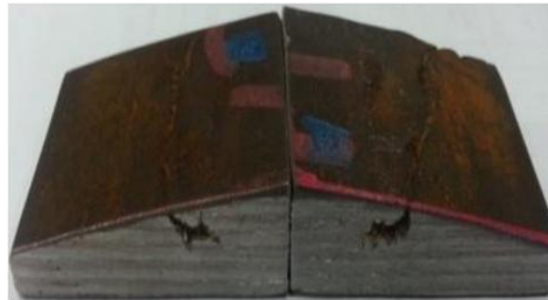
Figure 1. The sample shape of the previous stage for slice specimen

Fig. 1 shows the shape of the ingot and the collected specimen before preparing for the slice specimen among the four specimens used in this study.

(a) Alloy steel ingot(b) Specimens shape
