# DETECTION OF THE EARTHQUAKE DAMAGED BUILDINGS FROM POST-EVENT AERIAL PHOTOGRAPHS USING PERCEPTUAL GROUPING

The collapsed buildings due to Izmit, Turkey earthquake that occurred on 17 August 1999 were detected from post-event aerial photographs using the shadow analysis and the perceptual grouping procedure. The selected area of study is a part of the city of Golcuk, which is one of the urban areas most strongly hit by the earthquake. The area contains a total of 282 buildings, of which 79 are collapsed and 203 are un-collapsed. First, the Canny edge detector was applied to detect the edges between the cast shadows and the surroundings. Second, the output edge image was converted into vector line segments through a raster-to-vector conversion process. These line segments were then grouped together using a two-level hierarchical perceptual grouping procedure. The boundaries of the buildings were available and stored in a GIS as vector polygons. Therefore, after the perceptual grouping procedure, the damage conditions of the buildings were assessed on a building-by-building basis by measuring the agreement between the detected line segments and the vector building boundaries. The r

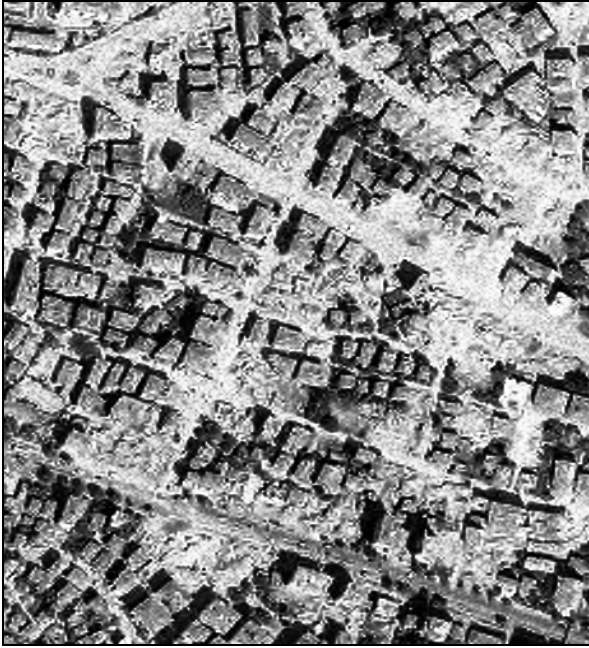
Figure 1. Study Area.

The selected study area is the part of the city of Golcuk, which is one of the areas most strongly hit by the earthquake. It is located on south coast of Izmit Bay, which is east-west elongated structural basin situated along the North Anatolian Fault (NAF) at the eastern margin of the sea of Marmara. The study area contains a total of 282 buildings. Of these buildings, 79 were fully damaged and collapsed and the remaining 203 buildings were un-collapsed. The post-event aerial imagery dated September 1999 (1:16,000-scale) was used for the analysis (Figure 1). The imagery was supplied by the General Command of Mapping (GCM) of Turkey.

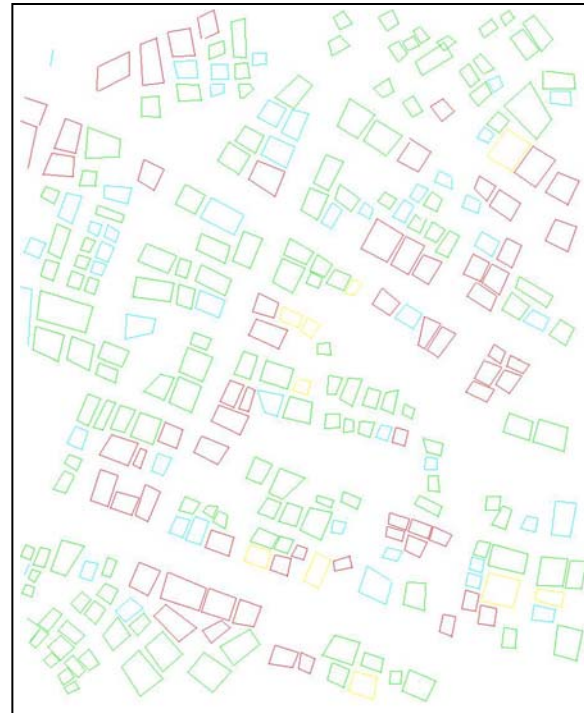
Figure 6. The results of the assessments.

For un-collapsed buildings, the user's accuracy was found to be remarkably higher than that of collapsed buildings. The producer's and user's accuracies of un-collapsed buildings were computed as 70.0% and 89.9% respectively. Of the total 203 un-collapsed buildings, 61 were omitted from this category while 142 were labeled correctly. The assessment results are also illustrated graphically in figure 6. In the figure, the green colored buildings represent the un-collapsed buildings. The red colored buildings represent the collapsed buildings. The yellow and the blue colored buildings represent the omission error for collapsed and un-collapsed buildings, respectively.

The erroneously categorized buildings were further investigated to find out what might have caused them to deviate from reference data. It appears that the main reason for 16 collapsed buildings to be wrongly categorized as un-collapsed is the spacing between the buildings. The rather short distance between the buildings caused the line segments detected through perceptual grouping to match with the wrong buildings. Therefore, 16 collapsed buildings were wrongly labeled as un-collapsed. Similarly, 61 un-collapsed buildings were wrongly categorized as collapsed. There seems to be two main reasons that cause these false negatives. The first one was the absence of the edges on the boundaries of the buildings. It was therefore, impossible to find a line segment corresponding to the edges of the buildings. Of the 61 un-collapsed buildings, 38 were found to be erroneously labeled due to this reason. The second reason was the vectorization process, through which the line segments were detected and smoothed. The smoothing process might have changed the orientations of the line segments. Therefore, the difference between the orientations of the line segments and the edges of vector building polygons might have stayed above the pre-set threshold level. Therefore, because the rule of orientation does not work in
