# USING SATELLITE IMAGES TO DETERMINE ENVIRONMENTAL CHARACTERISTICS OF AN AREA : AN APPLICATION

G. Atay<sup>a</sup>, E. Ayhan<sup>a</sup>

Commission VII/, WGVII/4

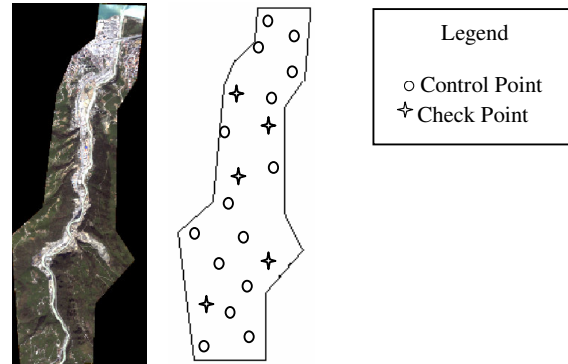
Figure 3. The workspace and distribution of points

Image rectification is a process by which geometric distortions in digital remotely sensed data are corrected. (URL 2). Geometric correction is undertaken to avoid geometric distortions from a distorted image, and is achieved by establishing the relationship between the image coordinate system and the geographic coordinate system using calibration data of the sensor, measured data of position and attitude, ground control points, atmospheric condition etc. (URL 3). In this study firstly image was rectified. The rectification process was done by using topographic maps scale 1:25000. For rectification 15 ground control points and 5 check points were used. The distribution of points is a very important issue during geometric correction. The distribution must be homogeneous. But because of physical characteristics of the land, sometimes it can't be possible to distribute points in a homogeneous structure. The workspace is also such a place. Because of that reason, the distribution of points done the most appropriate position. All the points were carefully selected and positioned that can be clearly identified both on the satellite image and topographic maps. Figure 3. shows configuration of points used.

Simple 1<sup>st</sup> order polynomial is used for image transformation. For image, RMS errors for all of the GCPs were calculated. Table 2 shows RMS errors for control and check points.

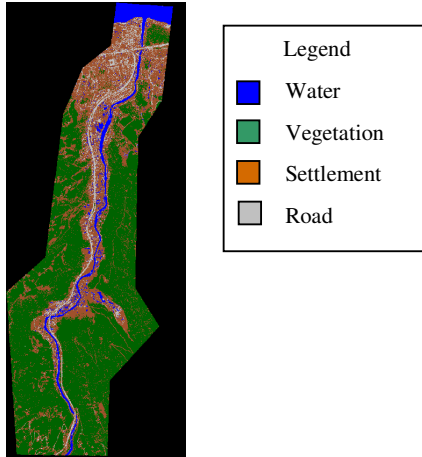
Figure 4 . Classification map of the workspace

Supervised classification method was used in order to examine digital data extraction possibilities. Training areas were selected using ground truth data and visual image interpretation. We determined four classes for classification. The classes were water, settlement, vegetation and road. Classification was carried out using Maximum Likelihood algorithm.

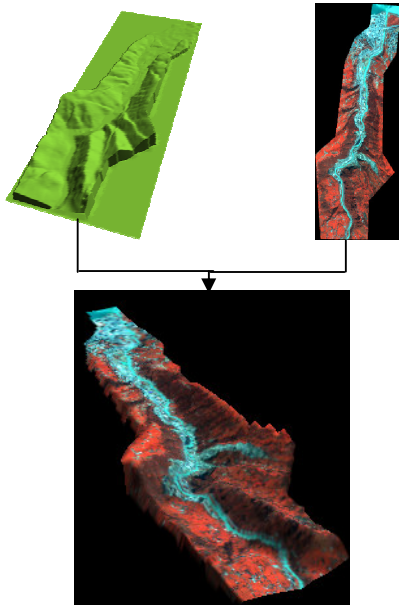
Figure 5. 3D model of the workspace

Firstly, obtained DEM (Digital Elevation Model) and rectified satellite image were joined. In this way 3D model of the workspace was achieved.

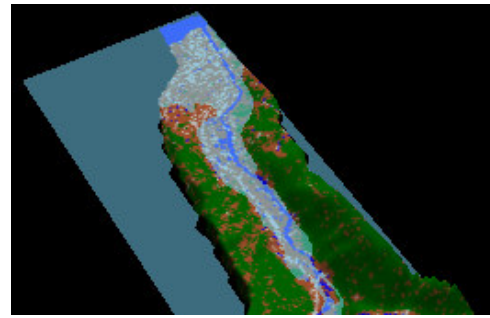
Figure 6. Visual implementation for flood disaster

We got documents about water height of the river of 2002 from Directorate of State Hydraulic Works (Primary executive state water agency responsible for water resources development in Turkey.) obtained from hydrographs. We determined the maximum water height in the year. According to the values of the height of the water we set 291 cm. and 284 cm. as the maximum values. These values belong to on 19 Sept. 2002 and 17 Apr. 2002. These values are not very high so these values did not cause a flood disaster in this year. We add about 2 meters to this value to show a probable risk zone. With Erdas Virtual GIS module by using a water layer the calculated value of water height was shown on the image. For this visual implementation classified image was used. Because the aim of this study is to show risky residential area. So we used an image showing residential area.

In this study we investigated only residential areas. With a cadastral data this study can be turned into detailed. Flood disaster is also very important for cadastral state. Such a study, cadastral parcels in the flood risk zone can be defined. A lot of interrogations such as; which parcels will be affected from a probable flood disaster, who belongs these parcels, if the parcels are agricultural land how the crop will be affected can be done. At the end of the study we got a visual result. According to this result residential area which is in the risk zone was determined. This visual result showed us most of the residential area near the river in the risk zone.
