# IMPROVED DISASTER MANAGEMENT THROUGH POST-EARTHQUAKE BUILDING DAMAGE ASSESSMENT USING MULTITEMPORAL SATELLITE IMAGERY

B. J. Adams<sup>a, \*</sup>

<sup>a</sup> ImageCat, Inc. 400 Oceangate, Suite 1050, Long Beach, California, 90802, USA –

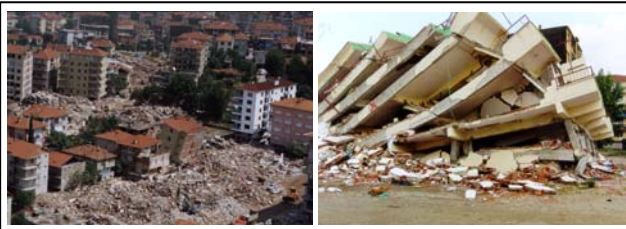
**3.1.1 Method:** Change detection algorithms were developed for the Turkish city of Golcuk, the most densely populated settlement in Kocaeli province. As illustrated in Figure 2, the city experienced extensive damage during the 17th August 1999 magnitude 7.4 earthquake. According to Coburn *et al.* (1999, cited in Rathje, 2000), 30-40% of structures collapsed, due mostly to pancaking and the soft first story effect.

Figure 2 Building damage in Golcuk (courtesy of R. Andrews)

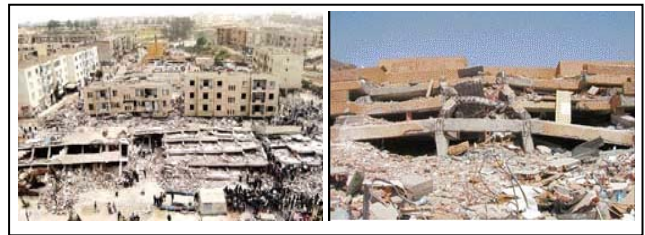
**3.2.1 Method:** Change detection algorithms were developed for the Algerian city of Boumerdes, located some 50km east of the capital Algiers. After the 6.8 magnitude earthquake struck on May 21<sup>st</sup> 2003, Boumerdes was among the worst-affected cities. Building damage was widespread (see Figure 7; also Adams *et al.*, 2003), with an estimated 150,000 people displaced from their homes (OCHA, 2003).

Figure 7 Building damage in Boumerdes (courtesy of AP Photo and EERI)
