# IMAGE CHANGE DETECTION ON URBAN AREA: THE EARTHQUAKE CASE

G. Bitelli <sup>a</sup>, R. Camassi <sup>b</sup>, L. Gusella <sup>a\*</sup>, A. Mognol <sup>a</sup>

**KEY WORDS:** Remote Sensing, Earthquakes, Change Detection, Disaster, Multitemporal

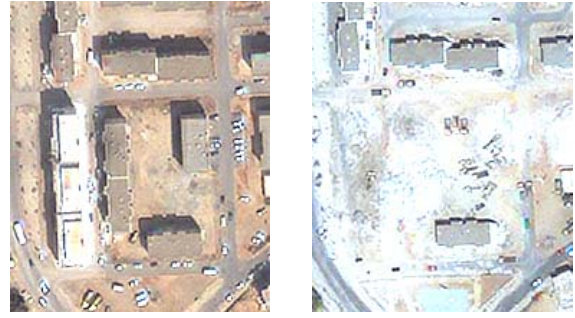
Using Quickbird pre- and post-event images is possible to produce a map of damaged buildings, as required by EMS 98 macroseismic classification, at least for higher grade of damage. However, two Quickbird images need correction and registration to have a correspondence between single structural units on two different images (Fig. 1).

Figure 1. Boumerdes, change between 2002, April 22 and 2003, June 18.

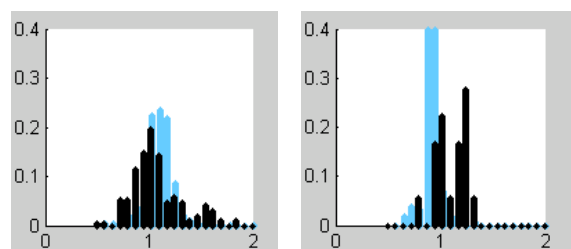
Figure 2. Left: ratio (post/pre event) in damaged buildings (black) and no damaged buildings (blue); Right: reflectance increasing in building and surroundings.

As can be observed in Figure 2 (left), it is quite impossible to define a threshold value to classify the damage using only roof reflectance. On the other hand, photo interpreters take into account surroundings of object/buildings to establish if a building is damaged or not: to simulate the surrounding of every building, a segmentation with an higher scale can be

performed, showing a significant increasing in reflectance on the damaged structures (Figure 2, right).

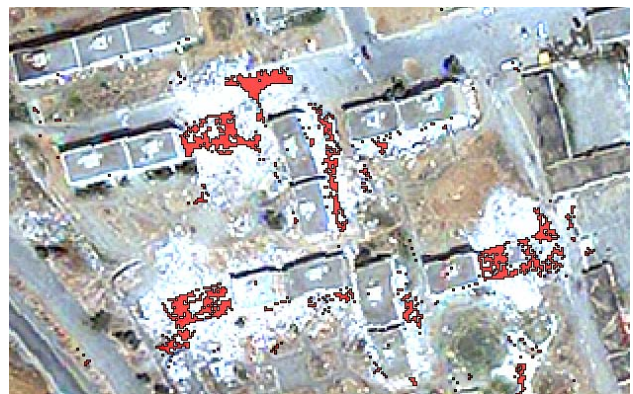
The change detection module was applied between pre- and post-event QuickBird images. In order to remove false changes caused by presence of shadows, ISODATA classification of pre-event image was used: a class for shadows was identified and removed by its implementation in the decision tree. Other two variables were used in order to select the urban area: ISODATA classification of pre-event image and NDVI of pre- and post-event images.

Figure 3. Boumerdes, change detection results by pixel-based classification.

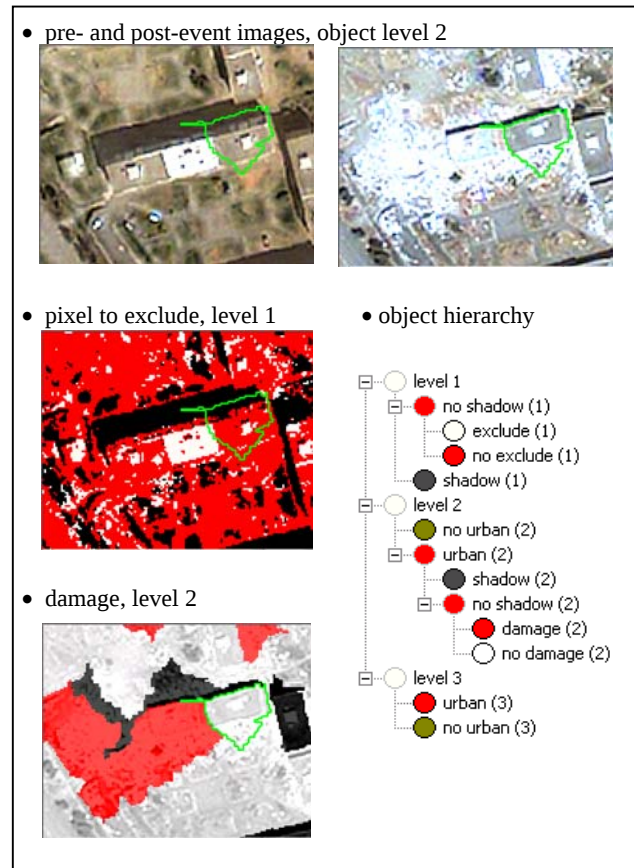
Using scale it is possible to recognize different objects at different scales in the image. For instance, it is possible to separate urban areas using a texture value (for example object standard deviation) or vegetation using the NDVI index, or other index like in the case of ERDAS decision tree classifier. The level hierarchy is composed by two levels at least, the texture (level 3, scale 60-120) and the urban built (level 2, scale 15-30). In the urban level, it is necessary to define how an object is perceived as changed. Human eye is able to recognize reflectance changes without considering shadows; contrariwise, using image differencing techniques, an increasing in reflectance could happen when a building falls across a shadow in the other image. Thus, a sublevel of urban level (level 1) is created, to simulate the possibility of human eye to recognize reflectance in non-shadowed zones. The final level hierarchy structure is summarized below, in Figure 4 and in Table 5.

Level 1 represent a classified layer of shadow and saturated objects. In fact, Quickbird imagery presents some artifacts, or saturated zones, that should be removed to calculate damage index only on meaningful pixels.

Level 2 is the object of interest level: in this level a change index, such as maximum absolute difference on multispectral images or ratio post/pre event in panchromatic, is calculated. There is a hierarchical relation between this level and the level below: in fact, the index will be calculated only for meaningful pixels (not shadowed and no saturated).

In the Level 3, with the largest scale factor, vegetation and texture index could be used to separate region of interest, such as urban areas, and to avoid vegetated area from classification. Large damaged areas, such as flooded areas in the Marmara earthquake, can be well separated on this level.

Figure 4. Object rules in eCognition, Quickbird image
