# MEASUREMENT OF GROUND DEFORMATION INDUCED BY LIQUEFACTION AND FAULTING IN THE 1999 KOCAELI EARTHQUAKE AREA

Commission VII, WG VII/5

**KEYWORDS:** Earthquakes, Soil, Photogrammetry, Measurement, Vector

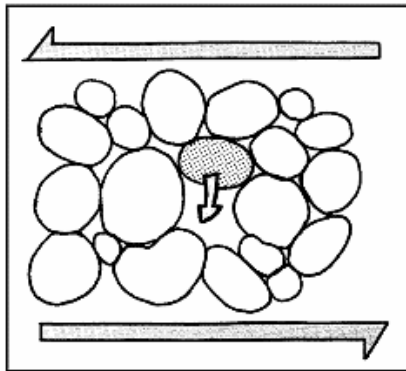
Figure 1. Liquefaction

Liquefaction is a process by which sediments below the water table temporarily lose strength and behave as a viscous liquid rather than a solid. Liquefaction of ground below ground water table is caused by the excess pore pressure due to shaking resulting from earthquakes or blasting. As a result the ground temporarily loses their strength and bearing capacity and it behaves as a viscous liquid rather than a solid (Figure 1). The actions in the soil, which cause liquefaction, are seismic waves and especially primarily shear waves. Liquefaction occurs in saturated soils, that is, soils in which the spaces between individual particles are completely filled with water (Youd, 1972).

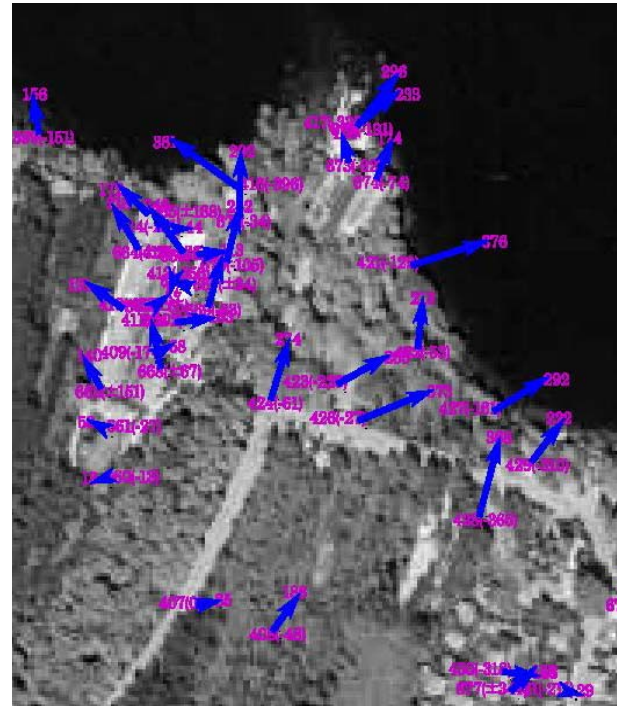
Figure 2. Displacement vectors around the Sapanca Hotel

Vectors obtained from Eşme measurements show a displacement implies especially with faulting in the east and southeast direction. Obtained vectors from the west corner of Sapanca Lake do not show a unique direction. There is a similar movement with that of Eşme in the north of the model, while sparse movement in the south of model because of varying soil structure and locating fault. And vectors in the area of Sapanca Otel have directions mainly to north, upward the Lake because of the liquefaction (Figure 2). To explain the results better, detailed measurements have been made at coastline area of first measurement regions too.

Based on the aerial photogrammetric evaluations conducted along the southern coast of the Sapanca Lake, displacement vectors determined show a liquefaction movement and confirm the site observations, which were done at liquefaction areas. It is also noted that towards the south part of Sapanca town, where liquefaction has not been observed, some displacement vectors were also determined. These vectors indicate some displacement contributing to the main deformations due to liquefaction induced lateral spreading along the coast of the lake. On the contrary to these, displacement vectors at the northern part of Sapanca Lake - Esme, at the northern part of left corner of Sapanca Lake are parallel to the fault, which caused the earthquake. At this part of the site no liquefaction has occurred, and therefore, it can be concluded that the permanent ground deformation is highly associated with the movement of the fault.

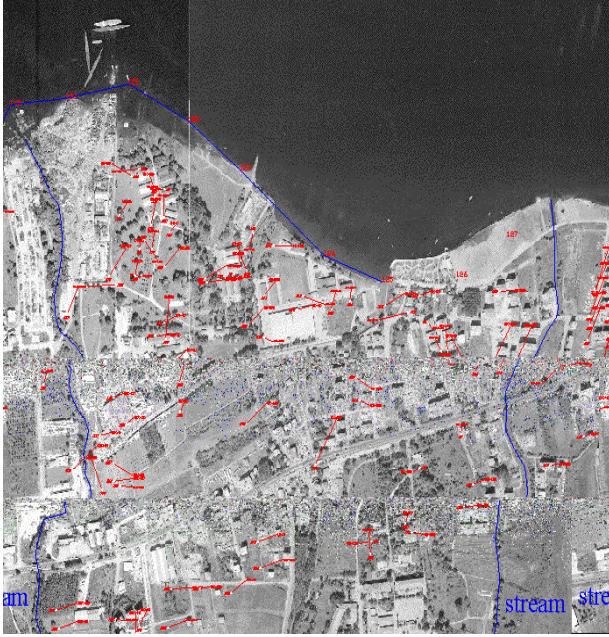
Figure 3. Displacement vectors at Seymen

Displacement vectors obtained from İzmit Bay measurements show a displacement implies mostly with faulting, but implies especially at coastline area with liquefaction too (Figure 3).

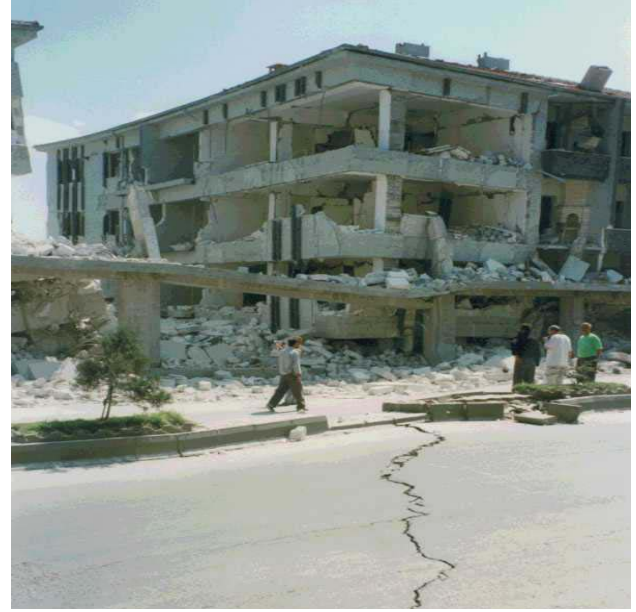
Figure 4. Displacements around Sakarya

Displacement vectors obtained from Sakarya measurements show ground deformation associated with faulting in the east and southeast direction (Figure 4).

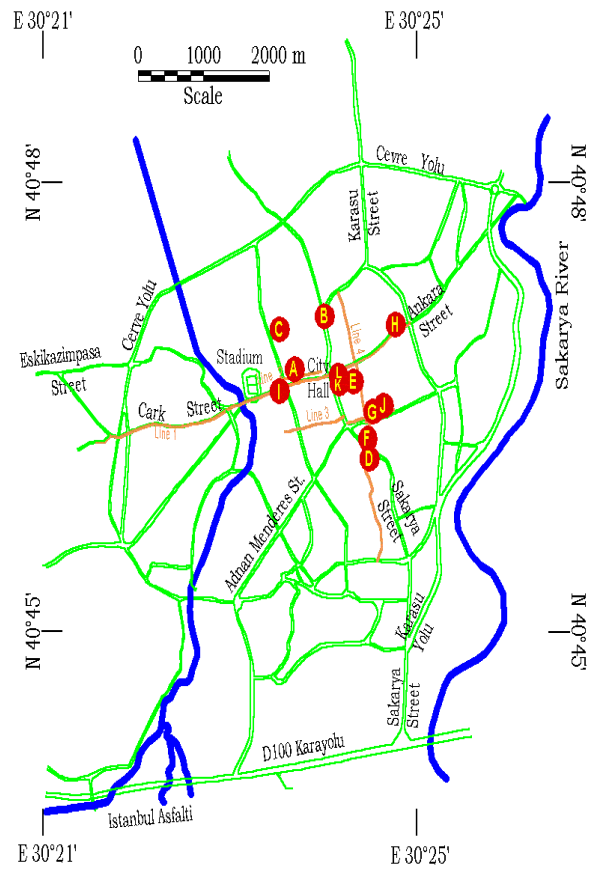
Figure 5. Measurement sites in Sakarya

Third phase measurements were also implemented in the Sakarya city center and at 12 different sites where US and Turkish investigators conducted detailed ground surveys and geo-technical investigations. Displacement vectors obtained from Sakarya city center are shown in Table III.

But at the same time, the effect of liquefaction can be seen in the changes of vertical coordinates. The detailed results are still being interpreted (Figure 5).

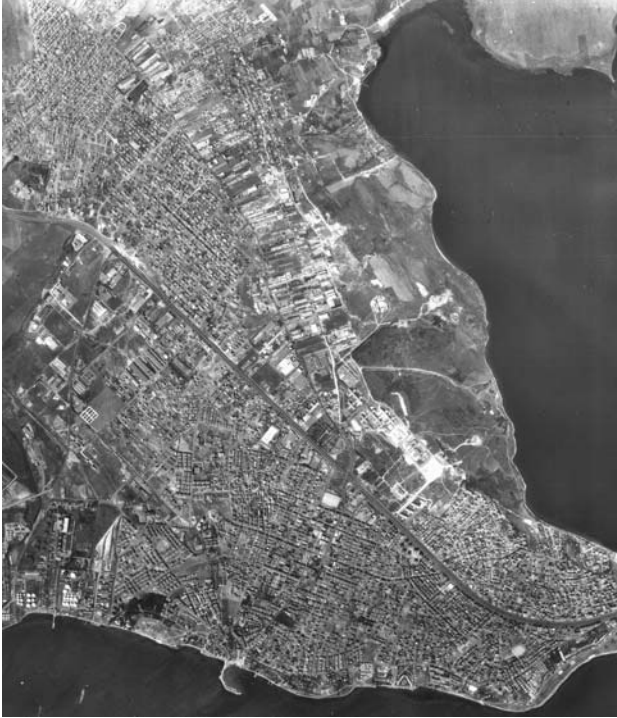
Figure 6. Aerial Photograph of Avcılar

And the last measurements were also implemented in Avcılar. In these measurements, aerial photographs taken in four different scales and time were used. These photographs were taken in 1987 and in 1:18 000 scale, in 1993 and in 1:35 000 scale, in 1998 and in 1:18 000 scale and after earthquake in 1999 and in 1:16 000 scale (Figure 6).

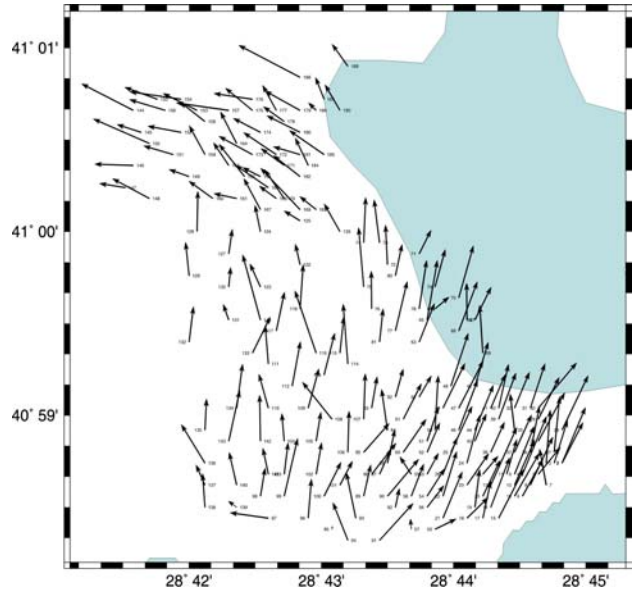
Figure 7. Displacement vectors for horizontal coordinates between the years 1999 and 1987

These results show us that the movements have different characteristics in these measurements. The displacements between the years 1998 - 1993 have a reverse direction when they compared with the displacements between the years 1993-1987. And of course the displacements between the years 1999 and 1998 have also another characteristic because of the earthquake. But it is interesting that the displacements between the years 1993 and 1987 have same directions with the displacements occurred in the earthquake in horizontal coordinates (Figure 7 and 8).
