# A Comparative Evaluation of Shear Bond Strength Between Two Commercially Available Heat Cured Resilient Liners and Denture Base Resin with Different Surface Treatments

**AIM:** To evaluate and compare the shear bond strength between two commercially available liners and polymethyl methacrylate (PMMA) denture base resin with different surface treatments.

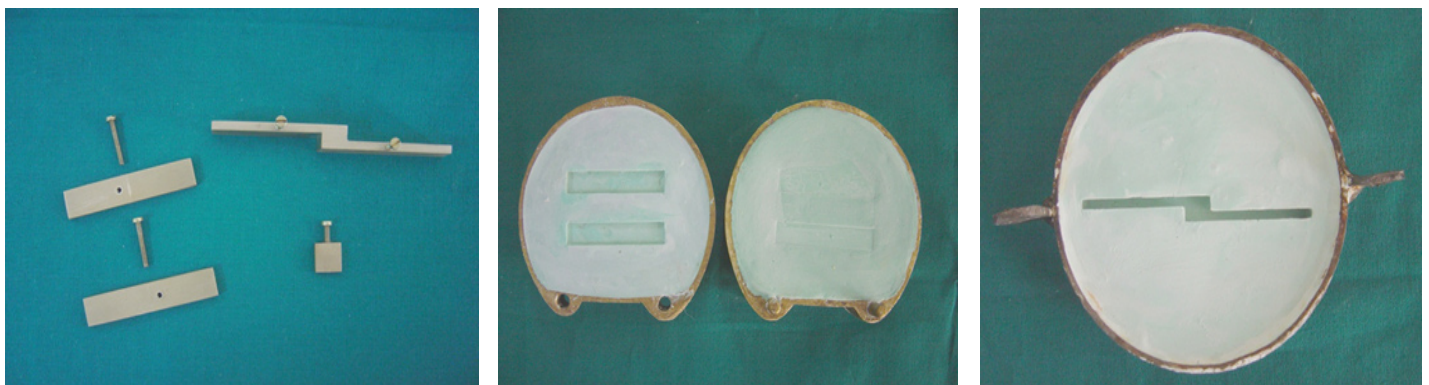
[Table/Fig-2]: Brass dies used in the study [Table/Fig-3]: Moulds prepared for acrylic resin strips [Table/Fig-4]: Mould prepared for making shear bond strength samples

**Fabrication of acrylic resin plates:** Brass metal dies measuring 50 x 10 x 3mm [Table/Fig-2] were used to make a mould in a mixture of 50% dental plaster and 50% dental stone [Table/Fig-3]. Mould was packed with denture base material and cured as per manufacturer's instructions.

**Design of the model for the application of the soft liner:** The acrylic samples used in this study were based on the test adapted from the American Society for Testing Materials (ASTM) test version D -2295-72 [5]. Using a brass die [Table/Fig-2] a mould was created [Table/Fig-4] for application of the soft liner.

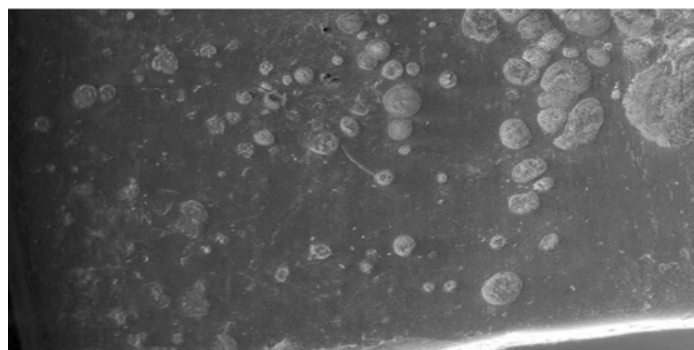
**[Table/Fig-9]:** Scanning electron microscope analysis: Interface of the bond between the acrylic based liner and denture base resin is not distinct

Material A (Silicone Liner) showed lesser mean bond strength compared to Material B (Acrylic Liner). Acrylic Liner had a composition similar to the PMMA denture base acrylic resin. The intimate nature of the bond can be co-related with SEM observations where interface of the bond between the acrylic based liner and denture base resin is not distinct [Table/Fig-9]. Comparatively SEM analysis of the control sample [Table/Fig-10] of silicone liner bonded to the denture base shows the distinct interface between the silicone liner and the denture base. No chemical bond would occur between them. To further enhance the bond strength surface treatments were done on the denture base for both the materials.

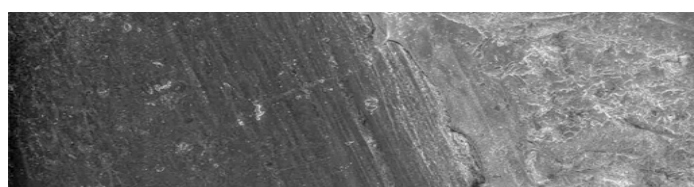
**[Table/Fig-10]:** SEM analysis of the control sample of silicone Liner bonded to the denture base shows a distinct interface

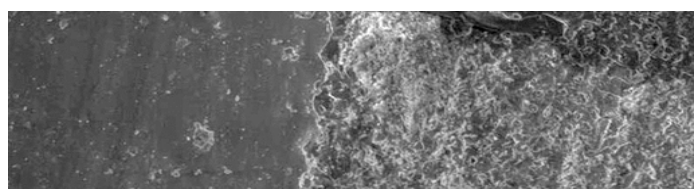
**[Table/Fig-11]:** SEM Analysis: Silicone Liner shows a distinct interface with sandblasted samples of denture base resin

The above readings could be co-related with the findings of the SEM in which Material A (Silicone Liner) shows a distinct interface for sandblasted samples [Table/Fig-11] whereas an indistinct interface can be seen in Material B (Acrylic Liner) [Table/Fig-12].

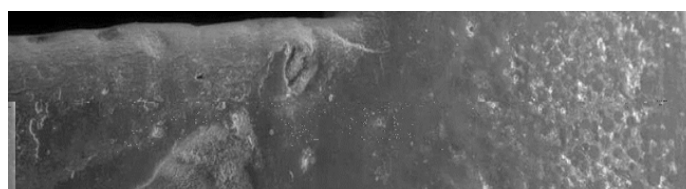
**[Table/Fig-12]:** SEM Analysis: Acrylic Liner shows an indistinct interface with sandblasted samples of denture base resin

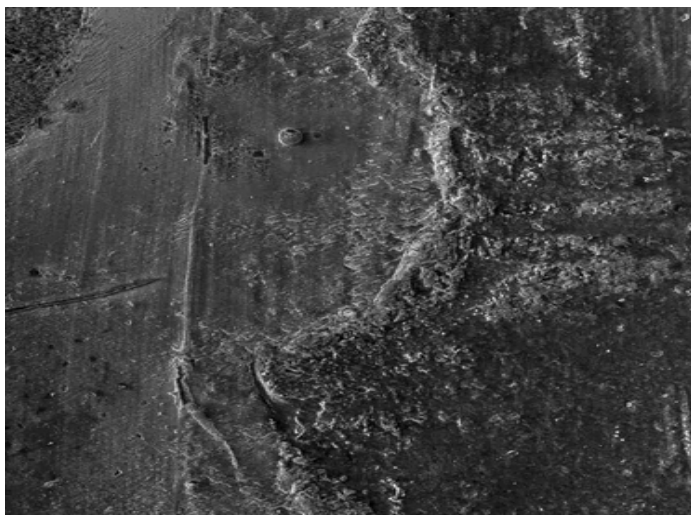
[Table/Fig-13]: SEM analysis of interface between silicone liner and monomer treated denture base resin

In case of Silicone Liners, using monomer and adhesive together may effectively increase the dissolution of the PMMA surface prior to the resilient liner application [10]. Another reason which can be suggested for higher bond strength value is monomer most probably reaches deep in to the polymer chains and facilitates the penetration of adhesive primer. Presence of significant bond strength values are a sign of absence or less micro leakage, the high bond strength values resulting from chemical surface pre treatments in the present study are similar to the results of micro leakage study by Sarac et al., [11]. The above could be co-related with the findings of SEM analysis. The shear bond sample of silicone liner bonded with monomer treated denture base clearly depicts the dissolved portion of the denture base into which silicone based liner has flown which helps in better mechanical retention than the control sample which has fewer undercuts for retention [Table/Fig-13]. In case of monomer treated samples of Acrylic Liner the increased surface area provided

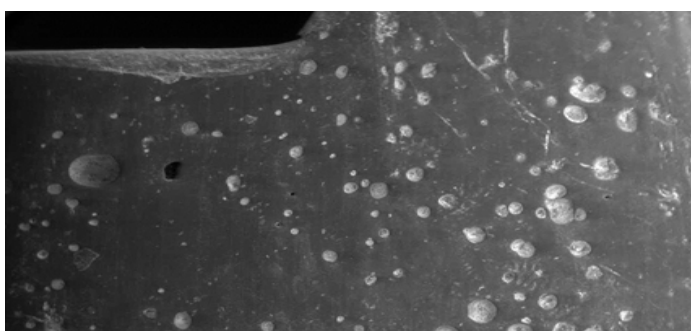
[Table/Fig-14]: SEM analysis of interface between acrylic liner and monomer treated denture base resin

due to dissolved denture base resin and similar chemistry of the liner helping in a chemical bond could be the reason for better bonding than in case of sandblasted and control samples [Table/Fig-14].

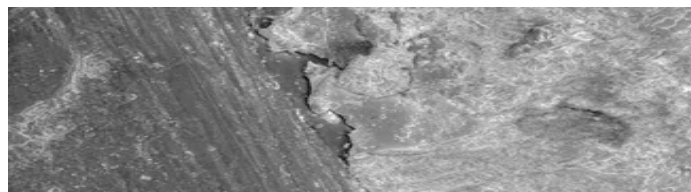
[Table/Fig-15]: SEM Analysis of samples prepared by packing silicone liner with pre-polymerized denture base resin

Pre-polymerized samples of the two materials under study have shown highest and lowest bond strengths. Material A (Silicone Liner) pre-polymerized samples showed lowest mean bond strength among all the groups under study whereas, Material B (Acrylic Liner) pre-polymerized samples have showed the highest bond strength among all the groups in the study. Different chemical nature of the silicone liner when packed against the dough stage may not provide the mechanical retention advantage as seen with the monomer treated sample, resulting in less intimate bond. This can be appreciated in SEM analyzed samples [Table/Fig-15]. Material B being an acrylic based liner has a very intimate bond with the denture base resin at dough stage. SEM analyzed bond interface of the pre-polymerized samples in acrylic Liner show a highly intimate bond where the junction of the bond is very indistinct [Table/Fig-16]. This could be the reason for the pre-polymerized Material B samples to achieve highest bond strength, of all the groups.

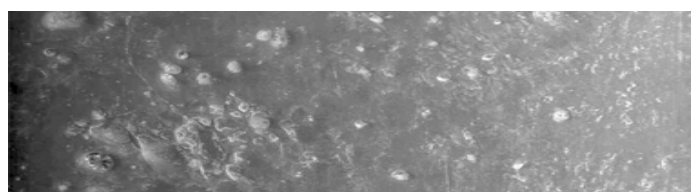
[Table/Fig-16]: SEM Analysis of samples prepared by packing Acrylic liner with pre-polymerized denture base resin

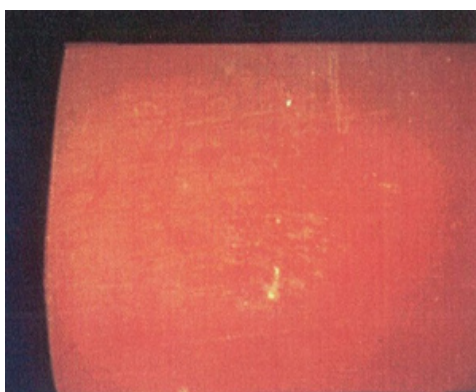
[Table/Fig-17]: Evaluation of adhesive failure under stereomicroscope [Table/Fig-18]: Evaluation of cohesive failure under stereomicroscope [Table/Fig-19]: Evaluation of mixed failure under stereomicroscope

Another aspect of the study was to characterize the debonding characteristics between PMMA denture base and the soft liners. They were classified as per the criteria given by Al-Athel MS et al., [13]. Silicone Liner samples showed adhesive failures [Table/Fig-17] for all the groups except monomer treated (Group III) which showed a mixed type of failure. Cohesive failures were mainly exhibited by Acrylic Liner in monomer treated and pre-polymerized samples [Table/Fig-18]. A cohesive failure indicated that the tensile strength of the soft liner was weaker than the bond strength to PMMA. The other groups of Acrylic Liner (Control and Sandblasted) however showed mixed type of failure [Table/Fig-19]. A mixed failure indicates that the bond strength of the liner was almost equal to the tensile strength of the liner. Adhesive failures indicated that tensile strength of the liner was greater than the bond strength with the denture base. A significant increase in the bond strength in monomer treated samples could be co-related with the mixed type of failure achieved with them, indicating it almost reached the tensile strength of the liner.
