# THE EFFECT OF MINING ON GEOMORPHOLOGY (Detection of changes by using Remote Sensing techniques)

The study focuses on the use of Remote Sensing techniques for the detection of changes and effects of mining on Geomorphology, especially the use of sequential images allow us to detect changes taken place from time to time. Nowadays, GIS and Remote Sensing are emerging as powerful techniques widely applicable in natural resource management and development. These techniques, not only enable a manageable storage and prompt access to large volumes of data, but also provide efficient tools to extract information/knowledge for logical decision making. Recent developments in Remote Sensing, Aerial Photography and GIS make it possible to detect changes and devise strategies based on these changes.

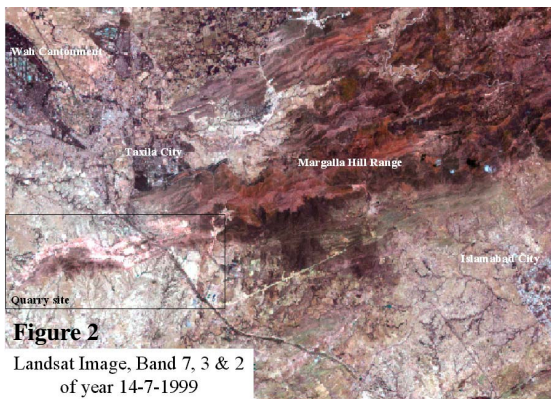
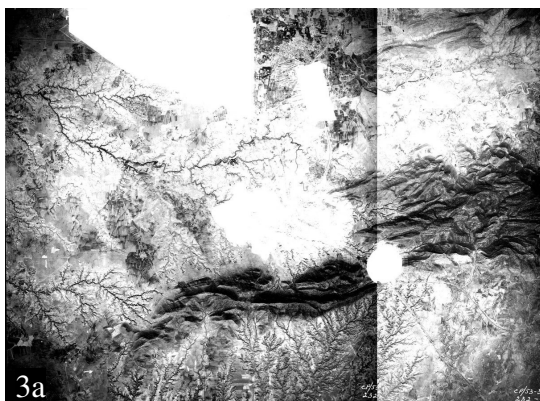
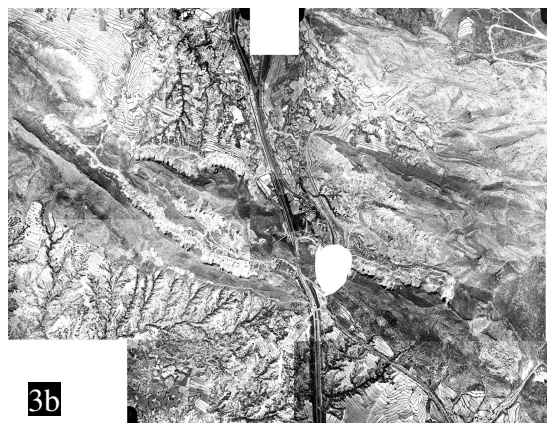
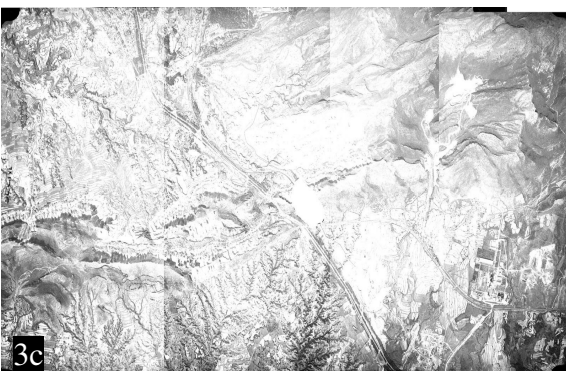
**Fig. 3a, b & c: Aerial Photographs taken in 1953, 1986 and in 1999 show the Margalla hill are being eaten up on the western side of the main Grand Trunk Road**

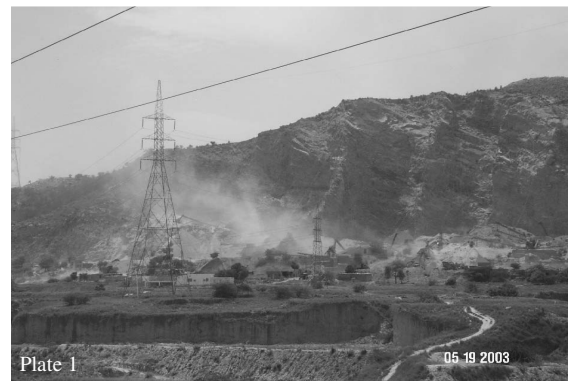
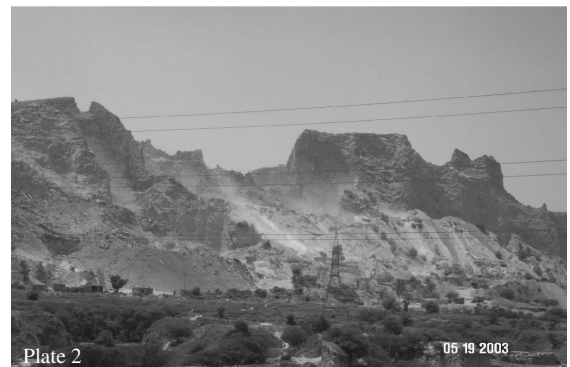
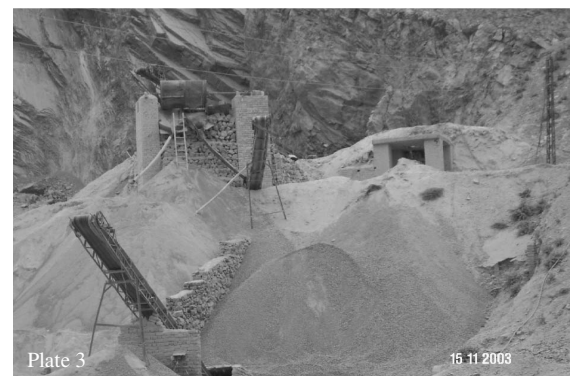
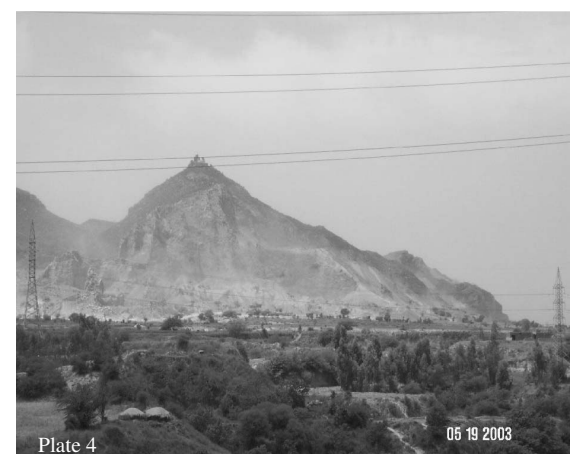
**Plate 1-4: Photograph shows the mining activities and the old traditional quarrying practices in Margalla Hill Range**

The study area lies at the border of Islamabad (the Capital of Pakistan) and Rawalpindi Districts. Geographically, it stretches from  $33^{\circ} 42'$  to  $33^{\circ} 44'$  north latitude and  $72^{\circ} 46'$  to  $72^{\circ} 52'$  east longitude (Figure 1). Margalla hill range starts from this point and further run north-west direction which ultimately joins the Murree mountain series. Islamabad, the Capital City; is located in the southern foothills of Margalla hill range. This area lies at a distance of about 30 km from Islamabad. From the last 30-35 years, when the Capital city came into being, after that time, the Margalla hills remained the main supplier of limestone for the construction of buildings, roads and bridges to the Islamabad and surrounding areas. Geologically, the rocks in the area range in age from Jurassic to Paleocene and are of sedimentary origin. It mainly comprises of sandstone and shale, which is very suitable for the construction of building and bridges. That is the reason that the beautiful and green Margalla hills are being eaten up by limestone mining and crushing activities (Figure 2), which in addition to the destruction of the natural landscape is causing large scale environmental degradation and air pollution. The site is exposed on the main Grand Trunk Road, which connects Islamabad with rest of the Punjab and North West Frontier Provinces of Pakistan. The available aerial photographs shows the situation before mining, during the mid of mining and now the latest situation. Figure 3a, b & c show the gradual depletion of the Margalla hill range. Aerial Photograph of 1953 (Figure 3a) shows the situation before the start of the mining activities, where the beautiful Margalla hill is standing proudly and increases the beauty of nature. While Figure 3b & 3c, which have been taken during 1986 and 1999 respectively, show that the beautiful Margalla are being eaten up by the mining activities. Plate 1 to 4 also clarifies the situation, where the crusher machines are eaten up the Margalla very hungrily.

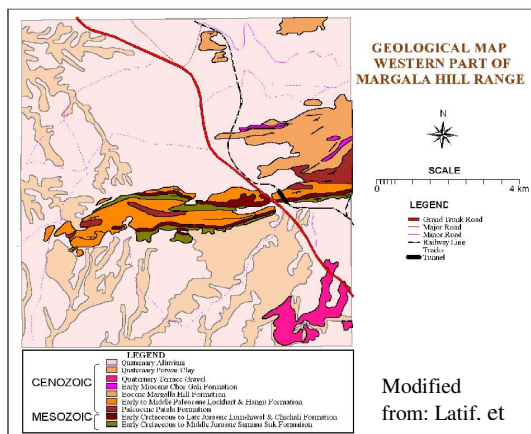
on screen digitization were used. When the contour were finalized after checking the redundancy and segment mode of the map, then these contour were interpolated by using the “Contour Interpolation” command in ILWIS. As a result DEM was produced which was further enhanced to get more attractive picture of the DEM (Figure 5a, and 5b).

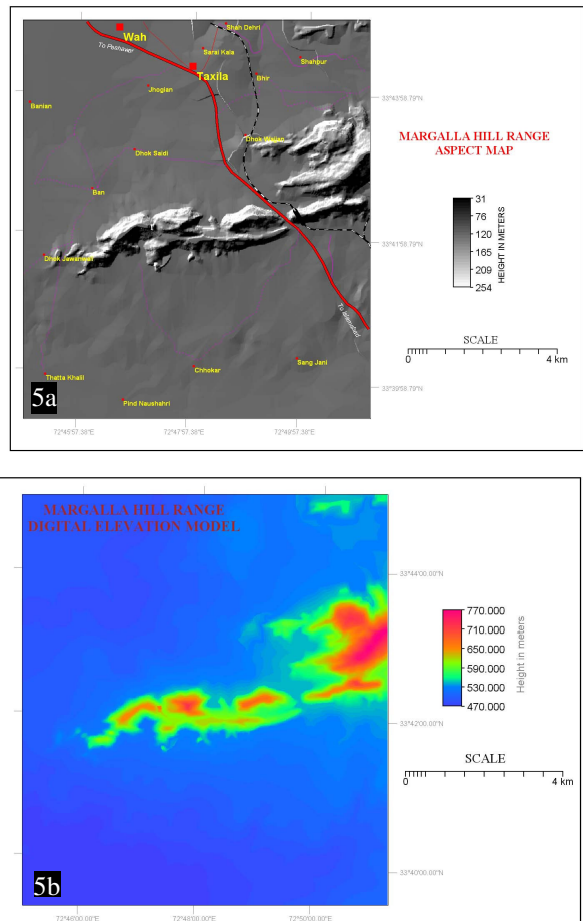
**Figure 5a: Aspect map derived from the enhancement of DEM**  
**Figure 5b: Digital Elevation Model derived after interpolating the contour on interval of 15m**

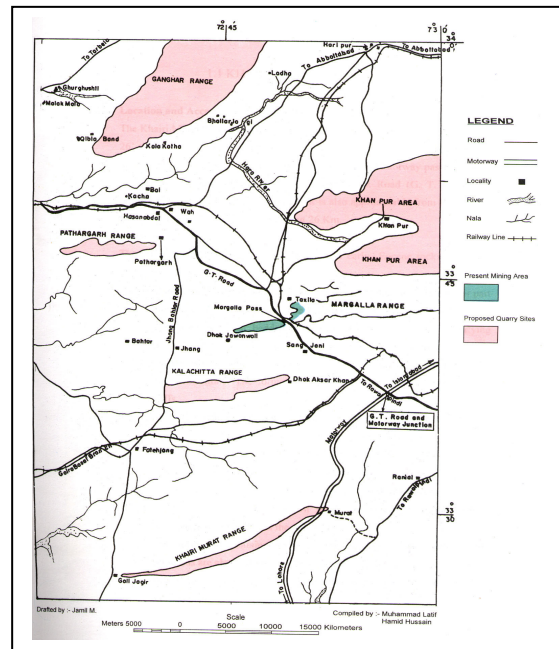
**Figure 6: Alternate Limestone quarry sites around Islamabad**

To reduce quarrying from the Margalla hill range, some alternate quarrying sites has been proposed for future mining and to preserve the beautiful Margalla hills from further quarrying. These sites are easily approachable through main road and situated at a reasonable distance from Islamabad and Rawalpindi districts (Figure. 6).

Based on the interpretation of the aerial photographs and studying other relevant data, it can be concluded that if the present quarrying remain continue, very soon the western side of the Margalla hills will be diminishes. Therefore five new proposed sites have been recommended. These sites are Khairi Murat, Kala Chitta, Pathargarh, Khanpur and Ganghar Ranges, which can be used for future exploitation for limestone aggregate in place of present Margalla hill range mining site. The reserves of limestone of all the five localities are enough to meet the present and future needs of construction material as compared to the present mining site, which will soon be depleted. The quality of limestone is more or less same in all these new localities as that of the Margalla Hills quarries.
