# LAND USE CHANGE DETECTION AND WATER QUALITY MANAGEMENT IN ISTANBUL'S WATER BASINS BY USING IKONOS IMAGERY

C.Baspehlivan <sup>a, \*</sup>, Ö.V.Sarıkaya <sup>a</sup>, A.Karaburun <sup>b</sup>, M.F.Döker <sup>c</sup>.

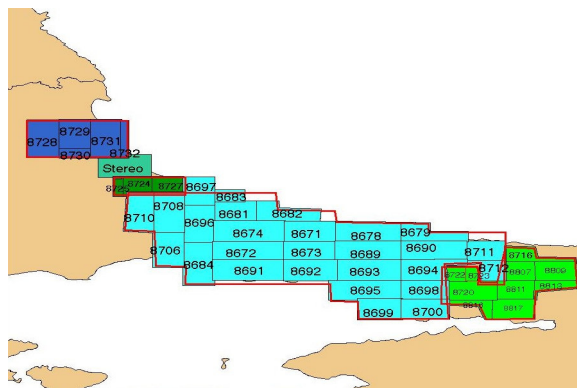
Figure 1.7500km<sup>2</sup> ISKI Study Area and IKONOS PO ID

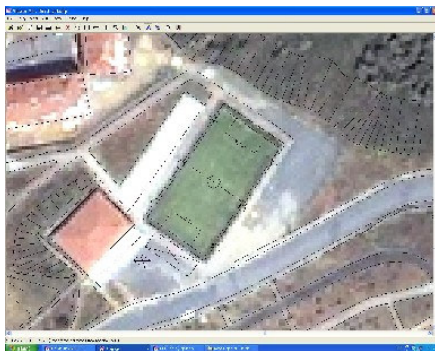
Figur2. Overlaid image of the orthorectified IKONOS image and topographic map.

Using the map data mentioned above, IKONOS HDD(PO ID) strips with approximately 350 km<sup>2</sup> areas were orthorectified within the 7500 km<sup>2</sup> project area. Associate points both on the image and topographic map were found and selected. For each orthorectification process approximately 22 reference points were collected. These points were selected from ways and low buildings. After the orthorectification process the precision found in the technical specification that was formed during the adjudication of the project was supplied. After the orthorectification process a  $\pm 1$ m RMS in the Istanbul city boundry and a  $\pm 5$ m RMS was obtained outside the city boundry.

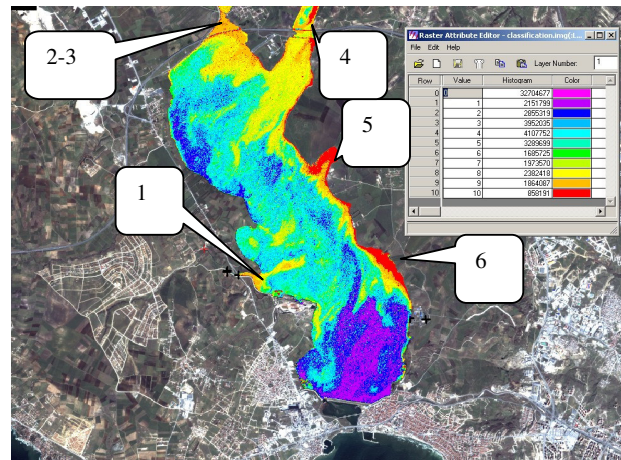
Figure-3 The thematic map of B.Çekmece lake obtained by unsupervised classification showing change in water (Total study area: 2753.63 hectares)

The red areas show the high TSM concentration while the purple areas show low TSM concentration. With the help of field study ISKI Map Department has found that there are 4 main stream branches that flow into the lake in the study area. In addition to this, 2 main stream branches not described as stream main branches according to the 20/02/2003 dated ISKI catchment areas protection and control regulation were taken into consideration as main stream branches after understanding from the thematic map (Produced from IKONOS imagery) that these 2 were causing the pollution in the lake.

It was seen that the 5 and 6 numbered streams carried higher TSM concentrations to the lake than the other streams that were taken into consideration. With the help of the examinations it was seen that when comparing with other streams, the 5 and 6 numbered streams were not under protection and the 4

IKONOS imagery (Separately recorded bands in Red, Green, Blue and Near IR) was used in this study. To avoid spectral mixture, the part containing water was cut out of the image according to the maximum water elevation boundry of the lake. The image that was cut out of the original image was classified with the unsupervised classification method.

It is being thought that the most important factor for the pollution that the streams bring into lake is the factor that the streams are not under protection. Furthermore, it has been observed that the muddy water coming from the settling pools in the refining facility near to the 6 numbered stream has no effect to the TSM concentration at this point.

The fact that pollution of the areas is caused by the fact that the streams are not under protection, it can be understood that the most important reason of pollution is not protecting the streams. In addition, the low TSM concentration observed at the places where the streams (under protection) and lake intersect supports this idea.

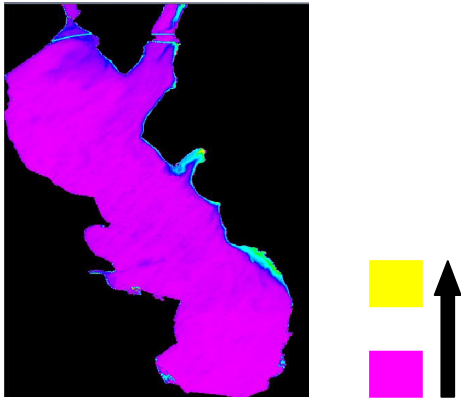
Figure 4: Chlorophyll index map produced from 1 m geometric resolutioned IKONOS image. (The direction of the arrow shows the increase in chlorophyll concentration.)

The possible effect of the chemicals found in the artificial fertilizer to the high chlorophyll concentration at the points where the 5 and 6 numbered streams flow into the lake should be examined. The pollution that can be arising from agricultural fields and settlements should be investigated more detailed.

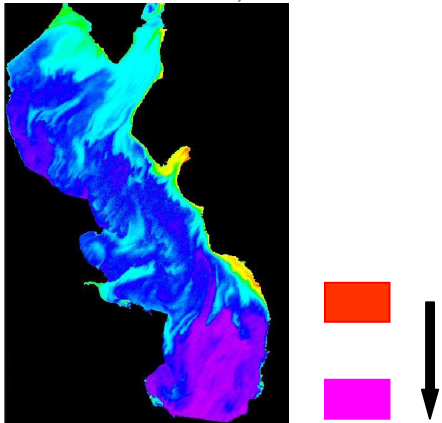
Figure 5: Clearness index map produced from 1 m geometric resolutioned IKONOS image. (The direction of the arrow shows the increase in clearness.)

It was observed that clear areas have lower TSM concentrations than polluted areas.

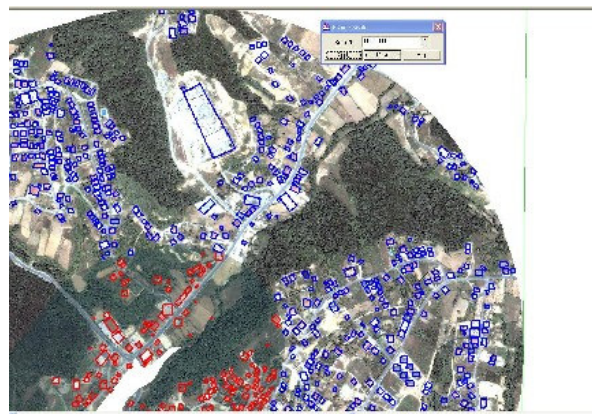
Figure 6: The View of The Digitized Buildings

Periodically taken and orthorectified IKONOS images are cut according to the zones of the catchment areas and the buildings are digitized with ArcINFO 9.0. Digitized buildings are transferred with their characteristics to form the Catchment Area Information System. With this system the temporal change in structure can be observed in the catchment areas. Work done in the desktop environment is going to be transported to ArcGIS server environment.
